CONSTITUTION PIPELINE

**ATTACHMENT Q**  
**TROUT STREAM RESTORATION REPORT**  
**New August 2014**

## **CONSTITUTION PIPELINE NEW YORK TROUT STREAM CROSSINGS**

August 2014

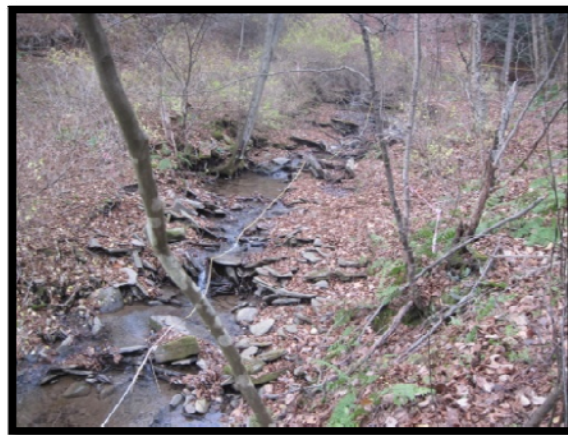
The streams in Group 1 have drainage areas less than one square mile and tend to be steep, step-pool channels dominated by boulder and cobble-sized bed material. These channels are generally confined, meaning the valley hillslopes meet the channel banks, resulting in steep banks and little to no floodplains. Given the steep slope of these streams, they are prone to incision from disturbances such as large, infrequent floods. However, given the lack of development within their watersheds, the extensive woody riparian vegetation observed at these sites, and the coarse substrate (i.e., boulders and cobbles), these sites are generally considered to be vertically stable under current conditions. No visual evidence of recent or active channel incision was observed at these sites. Due to lack of observed recent or historic bank erosion, these sites are also deemed laterally stable.

**FIGURE 3. EXAMPLE OF STREAM IN GROUP 1 (BR-II-S190).**

Because of the steepness of these streams, the proposed restoration approaches for Group 1 focuses on channel grade control after pipeline installation. As these channels were considered relatively stable under current conditions, replacement of native bed material and reconstruction of step-pool morphology using existing onsite boulder and cobble material is recommended, rather than the extensive use of engineered grade controls structures. Minimal pre-existing bank erosion was documented at the sites in this group, therefore bank stabilization measures will likely only be required where bank disturbance occurs. Due to naturally steep banks, Kleinschmidt recommends bioengineered bank stabilization measures for disturbed banks at most of these sites. Bioengineering methods utilize woody and herbaceous plantings, as well as erosion control fabric (Constitution ECP Section 5.22.2) to create earthen banks that are stable in the short and long term (e.g., Allen and Leech 1997).

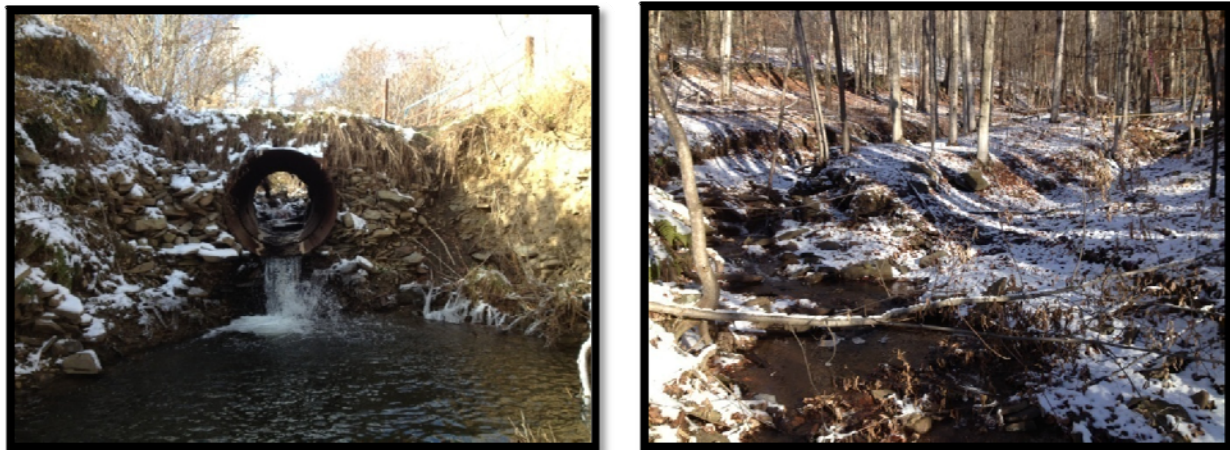
BR-1J-S048 is currently stable near the pipeline crossing; however, a perched culvert on an existing farm road located approximately 160 feet downstream of the pipeline crossing is at risk of causing vertical instability at the crossing site, should the culvert fail and the headcut move upstream.

**FIGURE 4. EXAMPLE OF STREAMS IN GROUP 2: PERCHED CULVERT DOWNSTREAM OF BR-1J-S048 (LEFT) AND INCISED CHANNEL AT SC-1Q-S278 (RIGHT).**

Restoration at these sites focuses on more extensive grade control within the construction ROW. Buried log grade controls, such as Figure 111 in Attachment A, or boulder cross vanes, such as Figures 112 and 114 in Attachment A, are recommended for streams in this group. More extensive bank stabilization may also be needed where banks have been undermined by channel incision. This includes bank re-grading and more extensive bioengineered bank stabilization, and potentially hard (rock) bank toe stabilization, using native boulders and cobble where feasible. Habitat improvement approaches are similar to those in Group 1 with emphasis on shading and the restoration of existing step-pool and riffle morphology using native bed material.

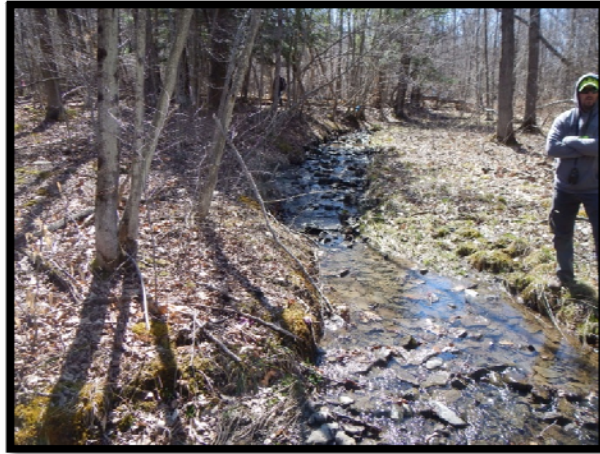
Streams in Group 3 share a similar drainage area as the previous two groups; however, they are less confined and tend to have a gentler slope (2-3%) than streams in Group 2. Being less confined implies that the valley walls do not always extend to the channel, thus the floodplain is well connected to the channel and the potential for significant bank erosion is reduced. In some cases, finer bed material such as cobble and gravel predominate. These streams are generally

considered to be vertically and laterally stable under current conditions, although some isolated bank erosion may exist.

**FIGURE 5. EXAMPLE OF STREAM IN GROUP 3 (DE-1G-S005, LOOKING UPSTREAM).**

Stream banks tend to be less steep on these streams, and restoring the grade of the bank, seeding/planting, and installing erosion control blanket should suffice without the need for significant bioengineering approaches for most sites. As noted in Table 1, BR-1I-S001 had less stable banks and Kleinschmidt recommends additional bioengineering methods at this site. As in previous groups, the use of native bed material to re-establish the bed is important. Streams in this group continue to be relatively narrow, limiting the use of typical habitat enhancing structures. Use of in-stream wood will provide habitat complexity, and Kleinschmidt recommends installing 6-10 pieces of large, native wood (saved from grubbing the ROW) at these crossings. Placement of the large wood should be directed by a geomorphologist familiar with placement of such structures in a stream. The placement of the large wood will occur both in the channel and on the floodplain, to provide cover for aquatic species and to replicate natural succession of trees in the riparian zone (See Section 5).

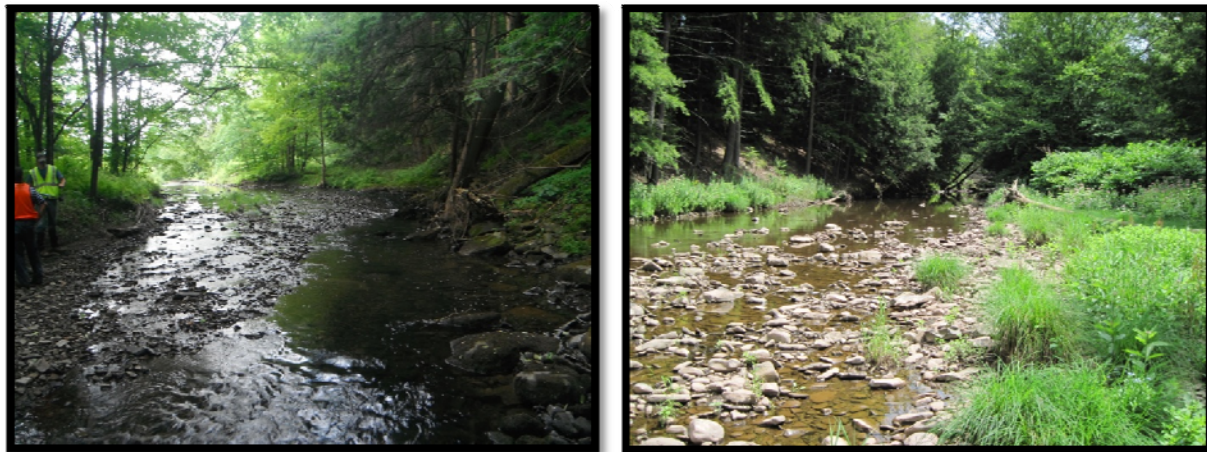
**FIGURE 6.      EXAMPLES OF STREAMS IN GROUP 4 (LOOKING UPSTREAM ON BR-1U-S141 [LEFT PHOTO] AND DE-1I-S201 [RIGHT PHOTO])**

Due to the width of these streams and a smaller concern of vertical instability, the restoration approaches for Group 4 focus on re-stabilization of disturbed banks, replacement of native bed material, and habitat enhancement structures rather than channel spanning structures.

Bioengineering methods may be required for stabilizing the disturbed banks, which are generally steeper at these sites. In-stream wood structures, such as rootwads and placed large wood can meet dual goals of protecting disturbed banks and providing habitat. Branch packing and live stakes along the banks of the disturbed areas are proposed at some crossings to quickly stabilize the shorelines and protect the steep banks.

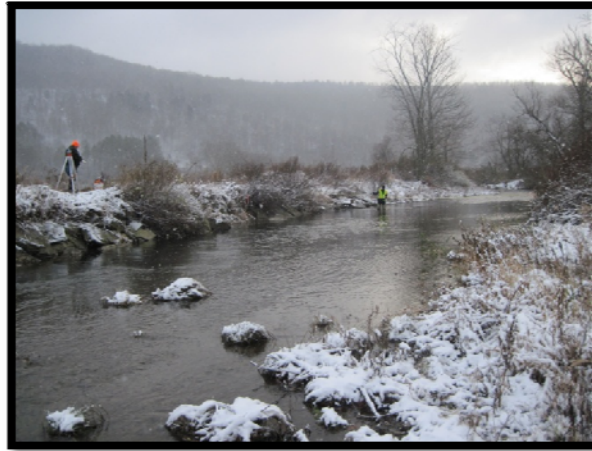
material, and generally accessible floodplains. For example, stream BR-1I-S057, Oquaga Creek (Figure 7), has boulder-sized riprap placed along its left bank. This material was likely placed there to inhibit bank erosion, but may actually be enhancing scour at the toe of the bank due to the improper placing of the riprap.

**FIGURE 7. EXAMPLE OF STREAM IN GROUP 5 (BR-1I-S057)**

More extensive bank erosion was noted at these sites. Bioengineered, bank stabilization methods are recommended throughout the length of the construction ROW to protect the stream banks from further erosion and to provide habitat and riparian cover for trout and other aquatic species. Habitat enhancement structures such as those discussed under Group 4 are proposed at these sites.

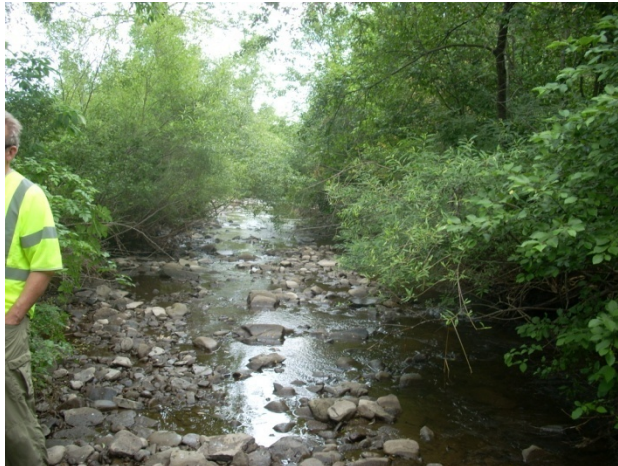
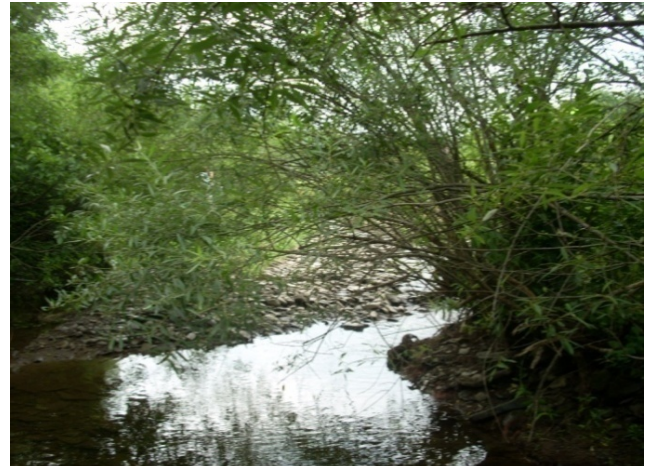
**Agency Site Visit (July/August 2013) Notes:** Use coffer dam and flume, stream is trapped but eroding banks toward RTE 17- possible need for vanes or armor to direct flow away from road. Need to check with DOT to see what they would like to see due to proximity to Rte. 17. Due to fact sites upstream and downstream have been disturbed DEC and USACE recommended potentially moving site upstream or downstream. Consider using rock vanes to direct flow away from banks, DS site: 4' cutbank in open/exposed area - more space for bore pit. DOT may prefer that banks be armored. USACE and DEC would prefer natural channel restoration.

**USACE/DEC Comments:** Seek to stabilize stream bank and protect road. Use natural channel design to protect the road - vanes and j-hooks. Consider crossing in an area that is already disturbed, either upstream or downstream.

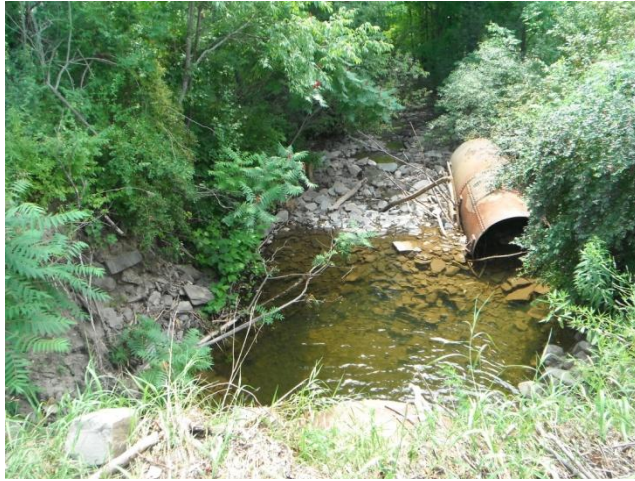
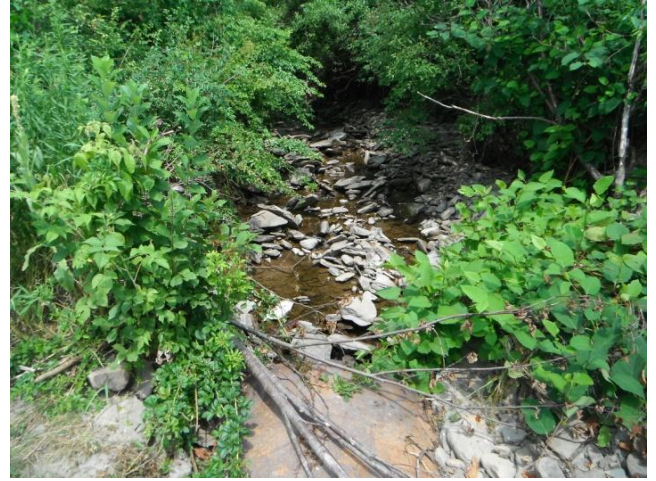
Access road would cross existing undersized culvert (~40" diam.) that is perched by ~4' on the downstream end and gravel has been depositing upstream of the culvert for some time. Flow has also been coming over the culvert with enough force to carry 12" rocks with it onto the top of the road. Any culvert replacements need to meet DEC regulations on their website. Dave mentioned installing grade control downstream and upstream to prevent exposure of the pipe from head cutting - cross vanes or step pools. Step pools could be vanes across stream with lowpoint at middle. There would be a need to design between the access road and the pipeline (~180') to protect pipe - this area is not currently in ROW and would need to be added. Mark and John (Williams) would prefer not to do full restoration - high cost, but for now the impacted areas were not changed. Consider moving, finding, or potentially building new access road. If the current stream crossing is used bury pipe deep to protect from head cutting should access road culvert fail.

**ACCESS ROAD: LOOKING DOWNSTREAM**

**ACCESS ROAD: LOOKING UPSTREAM**

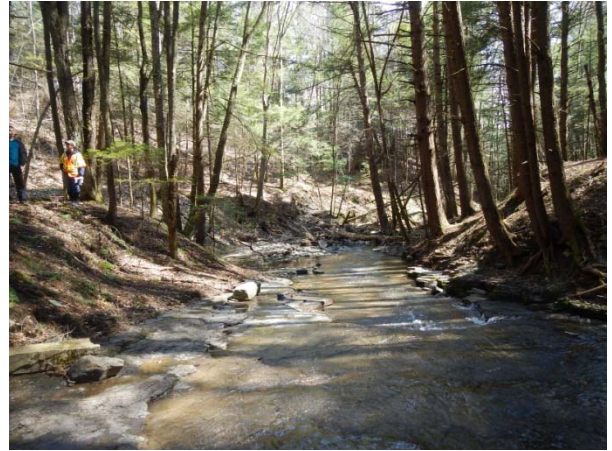
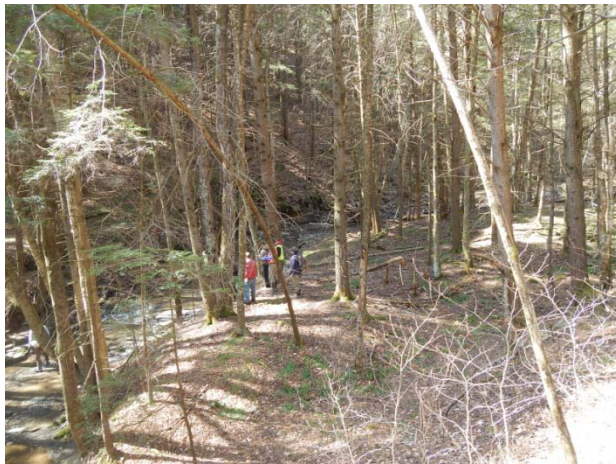
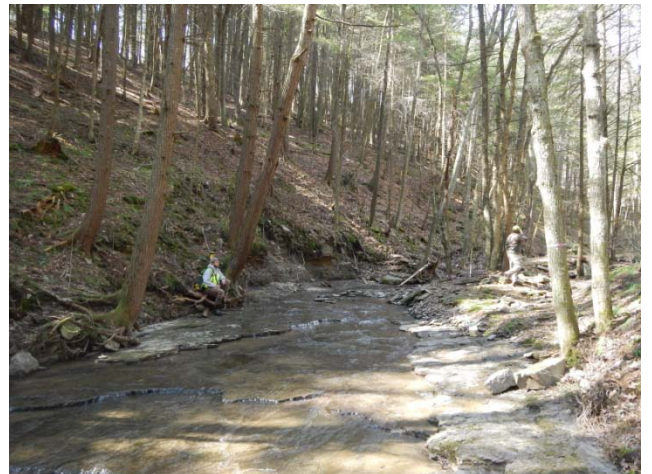
A reroute moved this stream ~300-feet downstream from the previous visits to avoid a landslide zone. Both the left and right banks are relatively steep and significant slope stabilization will be necessary to minimize erosion after installing the pipeline. The crossing is on bedrock and the DEC/USACE had concerns with the method used to close the trench over the pipe. They stated that concrete articulated mats have not worked on other sites and recommended avoiding the use of these methods. Since the substrate is ledge and has minimal habitat suitability for trout, the key issues are water quality related, minimizing loss of tree canopy, and preventing bankside erosion. USACE asked that the crossing be placed downstream of the 1.5' drop already existing in the bedrock to avoid further grade control after installation. The new crossing is ~10' downstream of the gradient change/step pool area. A Williams employee indicated that typically after blasting, the large sections of rock will be removed from the channel and replaced in the trench after the pipe is installed. USACE was concerned with "losing the stream" if the bedrock is significantly fractured. The use of flowable grout was discussed to minimize changing the groundwater flow. This would increase the length of time they needed to be in the stream, requiring a variance. USACE also wanted to clarify where the soil stockpile area was. The construction crew stated that it would likely need to be in the agricultural field at the top of the right bank due to space limitations near the stream. Overall, Agency and Williams staff felt that the new location is at a better crossing. Timing restrictions will apply to this (T) stream.

REROUTE CROSSING

REROUTE LOOKING DOWNSTREAM

REROUTE LOOKING UPSTREAM

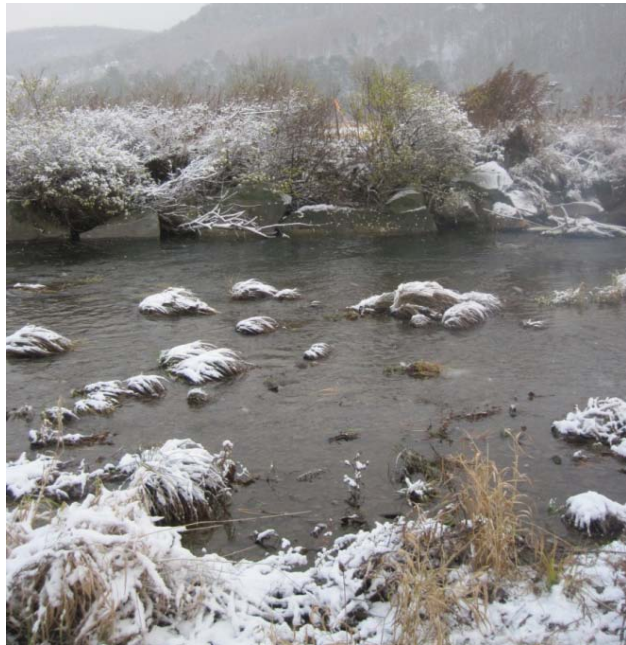
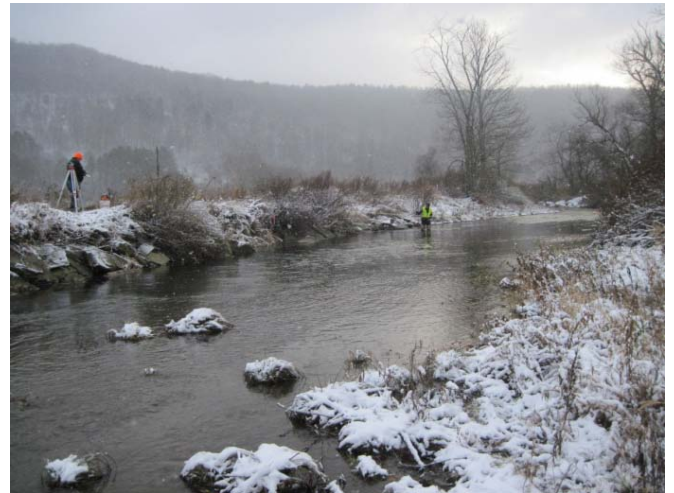
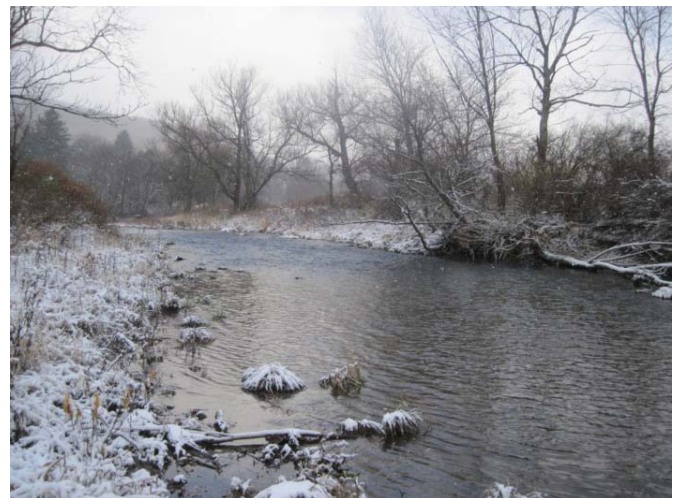
This riffle-pool stream has been significantly altered from its natural condition, as both banks are heavily armored in sections and there are agricultural fields right up to the top of the bank on the left bank, and within 35' of the top of bank on the right bank. The substrate was primarily cobble, with some boulders and some gravel near the edges of the stream. The system appeared fairly stable, as there was minimal evidence of downcutting or active scouring. There is a large riffle ~250' DS of the crossing that may potentially move upstream, and this is what the agencies wanted to protect the pipeline against, in addition to maintaining the bank protection. There was also some discussion of placing cross vanes or J-hooks on the right bank, downstream (and upstream?) of the crossing, to minimize the movement of the channel. The only floodplain is the agricultural fields, which are approximately 4-6' above the average water surface elevation. There was minimal evidence of flooding in these fields during either visit.

The stream banks were generally stable in the current condition, although significant armoring (3-6' boulders) had been placed along the channel. On the right bank, a rock wall (old bridge abutment?) was constructed from ~390' to ~200' US of the crossing. This "wall" served to protect the right bank as the stream made a left hand turn of about 45°. There was also armoring placed along the left bank from ~60' US of the crossing to ~110' DS of the crossing. This armor was just large boulders (3-5' along the long axis) placed against the bank – some of which were eroding between the boulders. There is also additional riprap placed on the RB ~250' downstream of the crossing, extending through ~450' below the crossing.

CROSSING

CROSSING: LOOKING DOWNSTREAM

CROSSING: LOOKING UPSTREAM

Moved crossing downstream ~100' to use disturbed bank and cross at riffle area that may be used by the farmer to cross his equipment. Trout were seen in the stream and Dave requested that trees be planted along the stream banks to provide shade for the stream as much as possible. The left bank is not well established - loose gravel/cobble. Potential for vanes to direct flow off of the right bank and provide grade control.

Plant trees along banks to stabilize toe of slope and banks.

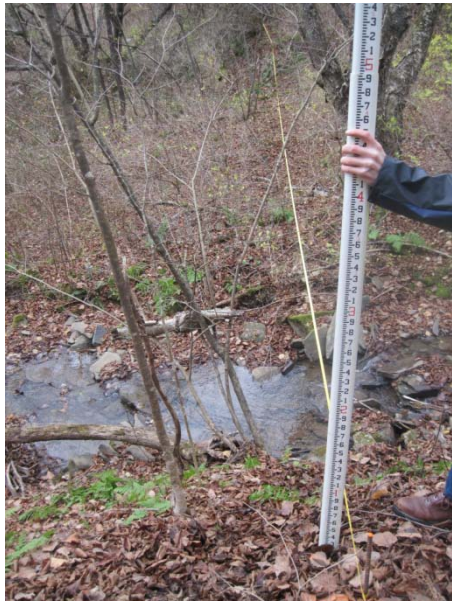
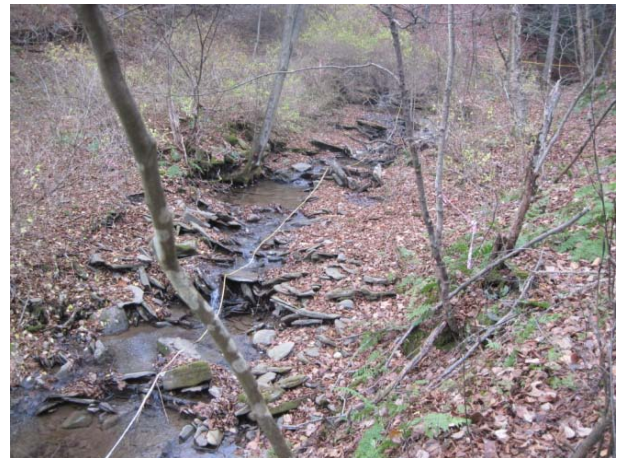
TRANSECT A (CROSSING)

TRANSECT A (CROSSING) LOOKING  
UPSTREAM

There is the potential for spawning and rearing of young trout at this site. Consider sloping the left bank at 3:1 rather than meeting existing grade which is over steepened.
