New York State Department of Environmental Conservation and
U.S. Army Corps of Engineers
Joint Application – Supplemental Information
Constitution Pipeline
Broome, Chenango, Delaware, Otsego, and Schoharie Counties

ATTACHMENT H WETLAND DELINEATION REPORT

WETLAND DELINEATION REPORT

Broome, Chenango, Delaware, Otsego and Schoharie Counties, New York

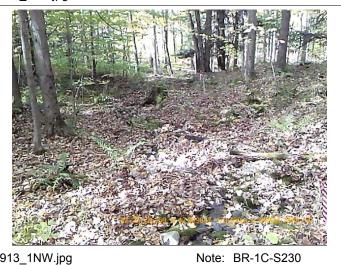
BR1CS230_100913_2SE.jpg Photo Name:

Note: BR-1C-S230
