CONSTITUTION PIPELINE

**ATTACHMENT Q**  
**TROUT STREAM RESTORATION REPORT**  
**New August 2014**

## **CONSTITUTION PIPELINE NEW YORK TROUT STREAM CROSSINGS**

August 2014

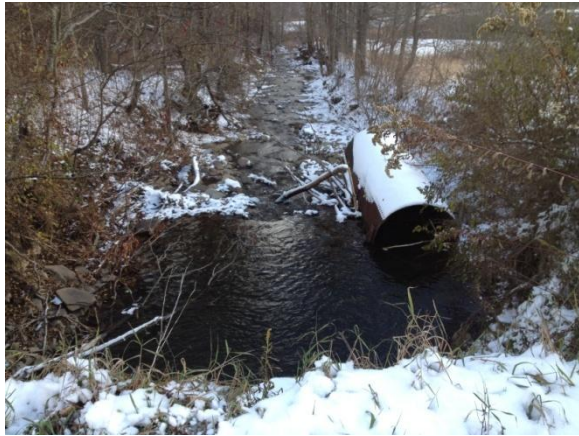
Access road would cross existing undersized culvert (~40" diam.) that is perched by ~4' on the downstream end and gravel has been depositing upstream of the culvert for some time. Flow has also been coming over the culvert with enough force to carry 12" rocks with it onto the top of the road. Any culvert replacements need to meet DEC regulations on their website. Dave mentioned installing grade control downstream and upstream to prevent exposure of the pipe from head cutting - cross vanes or step pools. Step pools could be vanes across stream with lowpoint at middle. There would be a need to design between the access road and the pipeline (~180') to protect pipe - this area is not currently in ROW and would need to be added. Mark and John (Williams) would prefer not to do full restoration - high cost, but for now the impacted areas were not changed. Consider moving, finding, or potentially building new access road. If the current stream crossing is used bury pipe deep to protect from head cutting should access road culvert fail.

**LOOKING DOWNSTREAM PAST THE CULVERT  
THE ACCESS ROAD**

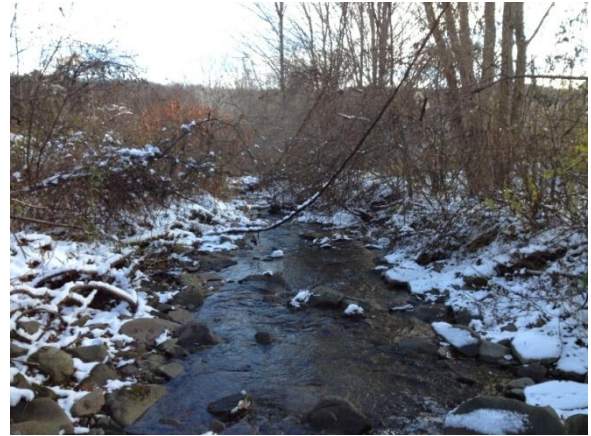
**CROSSING: LOOKING DOWNSTREAM UNDER**

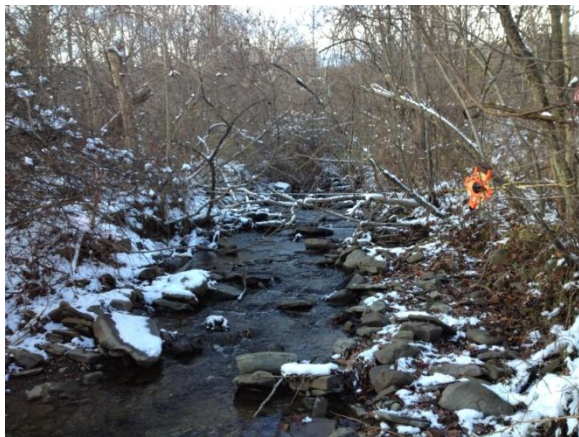
**CROSSING: LOOKING UPSTREAM**

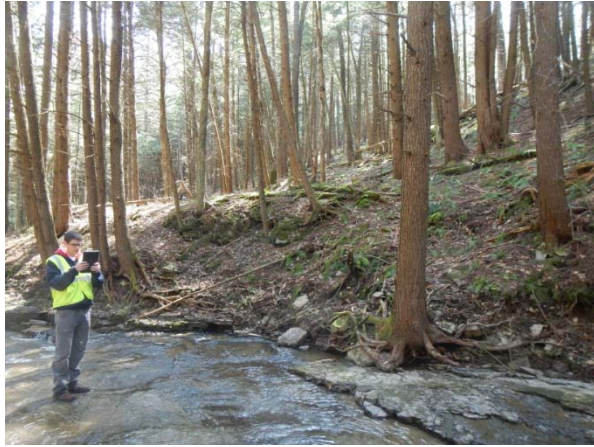
REROUTE CROSSING

A reroute moved this stream ~300-feet downstream from the previous visits to avoid a landslide zone. Both the left and right banks are relatively steep and significant slope stabilization will be necessary to minimize erosion after installing the pipeline. The crossing is on bedrock and the DEC/USACE had concerns with the method used to close the trench over the pipe. They stated that concrete articulated mats have not worked on other sites and recommended avoiding the use of these methods. Since the substrate is ledge and has minimal habitat suitability for trout, the key issues are water quality related, minimizing loss of tree canopy, and preventing bankside erosion. USACE asked that the crossing be placed downstream of the 1.5' drop already existing in the bedrock to avoid further grade control after installation. The new crossing is ~10' downstream of the gradient change/step pool area. A Williams employee indicated that typically after blasting, the large sections of rock will be removed from the channel and replaced in the trench after the pipe is installed. USACE was concerned with "losing the stream" if the bedrock is significantly fractured. The use of flowable grout was discussed to minimize changing the groundwater flow. This would increase the length of time they needed to be in the stream, requiring a variance. USACE also wanted to clarify where the soil stockpile area was. The construction crew stated that it would likely need to be in the agricultural field at the top of the right bank due to space limitations near the stream. Overall, Agency and Williams staff felt that the new location is at a better crossing. Timing restrictions will apply to this (T) stream.

Vegetation needed on stream banks to protect steep slopes. Minimize impact to Hemlock trees as much as possible.

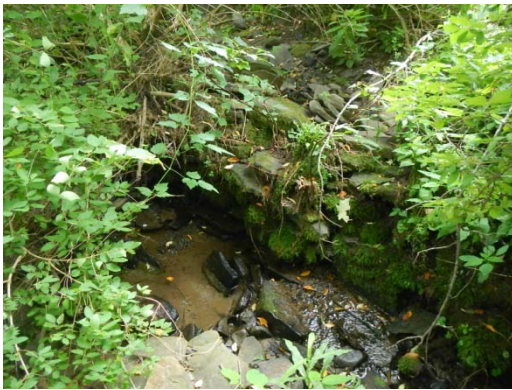
STONE WALL CROSSING CHANNEL

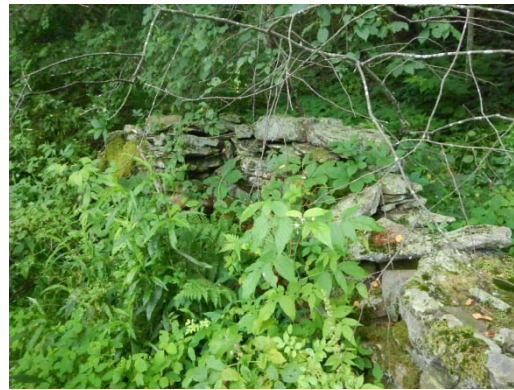
STONE WALL ON RIVER LEFT

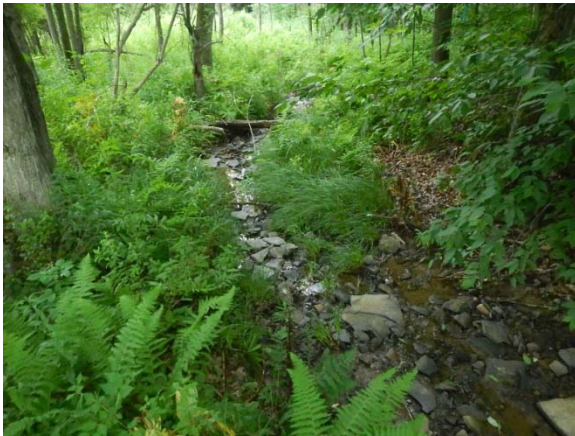
**CROSSING: LOOKING DOWNSTREAM**

A steeply sloped (6%) 1<sup>st</sup> order stream with some flow, though mostly standing water, which is discontinuous moving downstream. The current alignment places the crossing close to a gravel road just downstream of an existing power line right of way. The stream bed consists of cobble and gravel with mineral soil (sand and mud) exposed in between coarse material. Shallow step pools between tree roots indicate mild but active incision. The stream has low banks that are mostly undefined or ~ 1 ft tall, with no obvious bank erosion. The main channel splits into multiple unconfined channels downstream of pipeline alignment for brief period, then joins back to one main channel and has a low, broad floodplain. The stream is likely too small to maintain a trout population and lacks suitable spawning substrates. However, it drains directly to Dry Brook, which likely is trout habitat. Given the loose substrate, vertical stabilization will likely be needed downstream of pipeline trench.

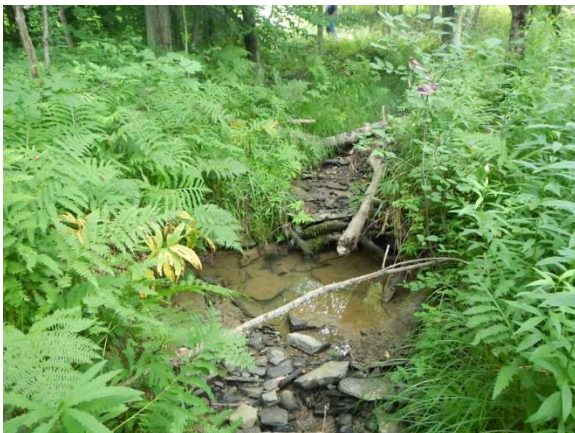
**SMALL BREAK IN STREAM PROFILE**

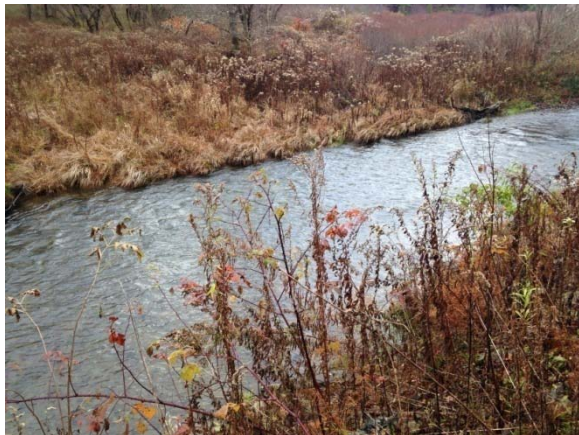
UPSTREAM BANKS

Utilize flat areas at base of slope as much as possible. Consider natural stream design to control direction of flow and protect base of slope.

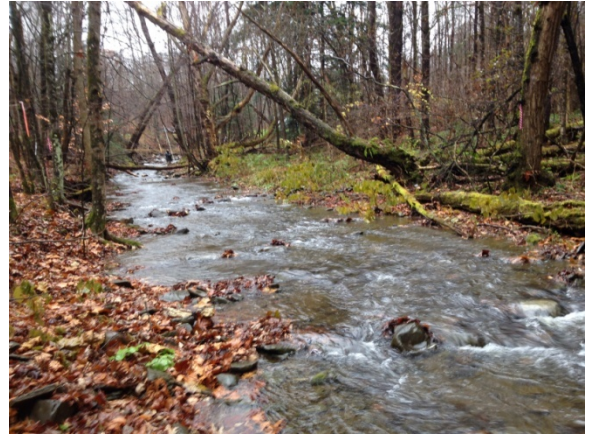
**CROSSING: LOOKING UPSTREAM**

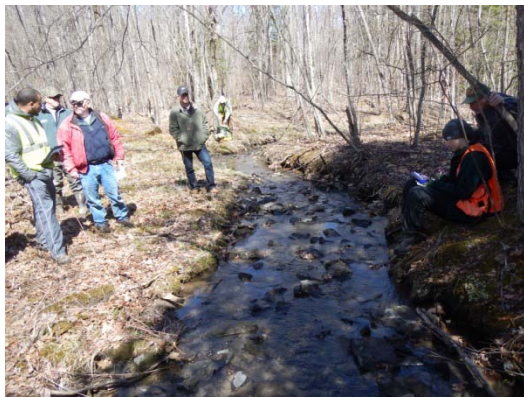
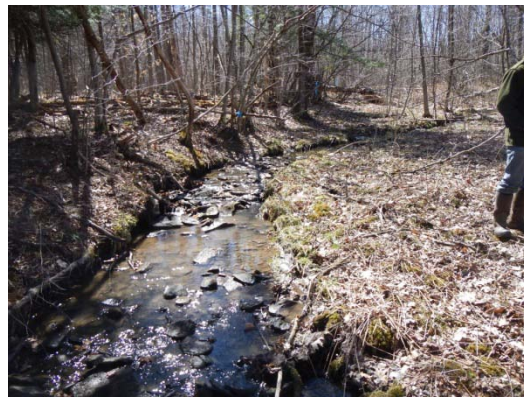
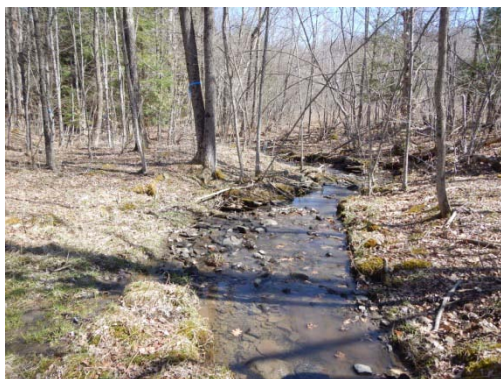
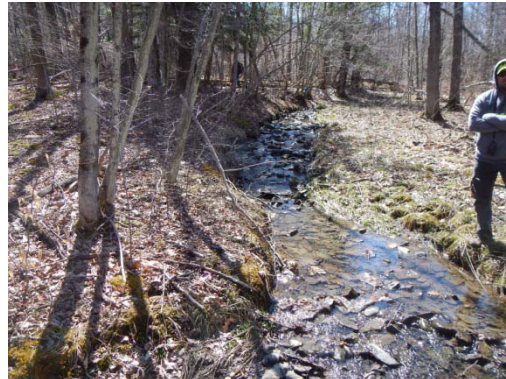
**DE-1G-S005**

A confined 2<sup>ND</sup> order stream located in a hardwood forest that has an estimated 1% slope. Cobble dominates the riffle habitat at this crossing. The stream channel and banks are somewhat stable although some signs of mild erosion (undercut banks) were evident. The right bank was vertically incised and the left bank has a 30 ft wide flood plain. At the time of the agency visit, continuous flow in the stream was estimated to be 0.5 cfs. Bioengineering techniques are recommended to stabilize the steep right bank at this crossing and provide shade over this reach. Timing restrictions will apply at this crossing.

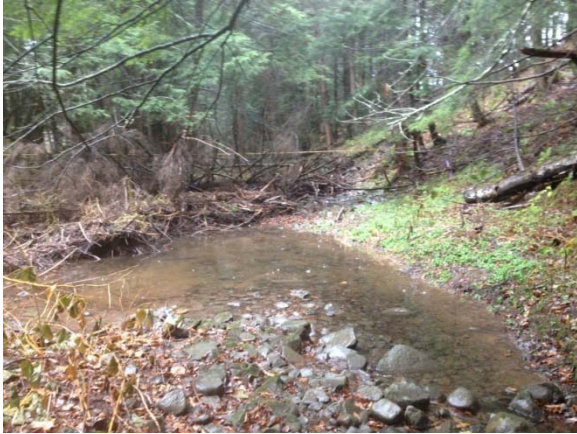
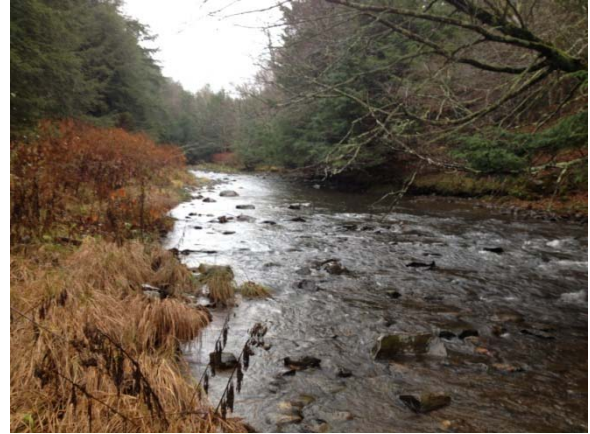
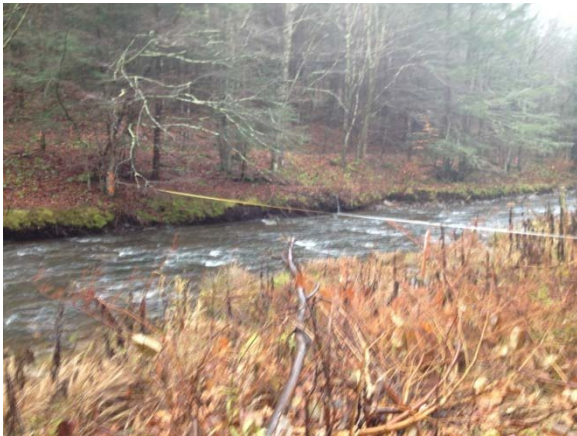
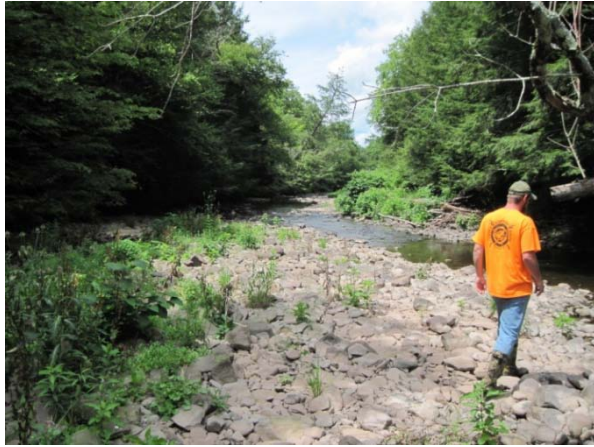
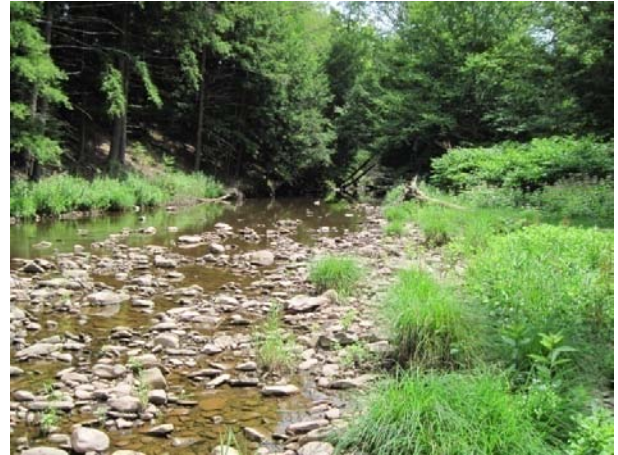
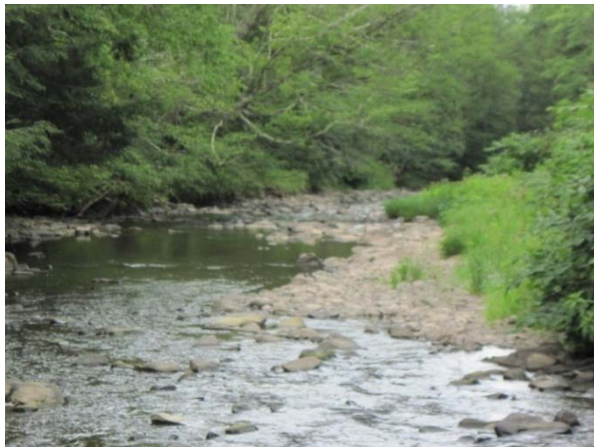
**DE-1I-S201**

Crossing is in a better location on straighter, riffle area. Will need to recreate and stabilize island area. Noted the side channel will need to be treated the same as the main stream, as bank full would be over the island.

DEC want replacement of habitat features. Toe wood structure is a suggested restoration. Surrounding Hemlock should be saved to the extent possible. High flow side channel is good nursery habitat and should be replicated.

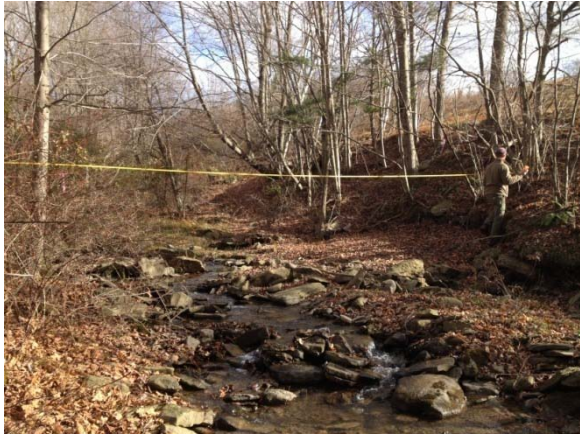
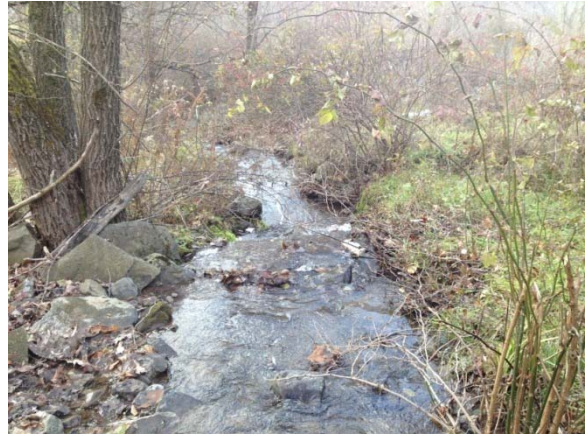
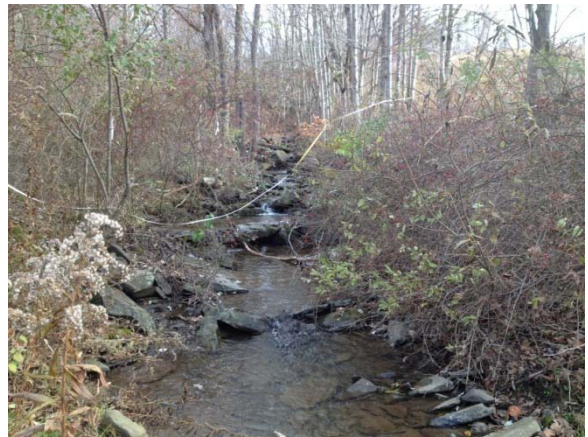
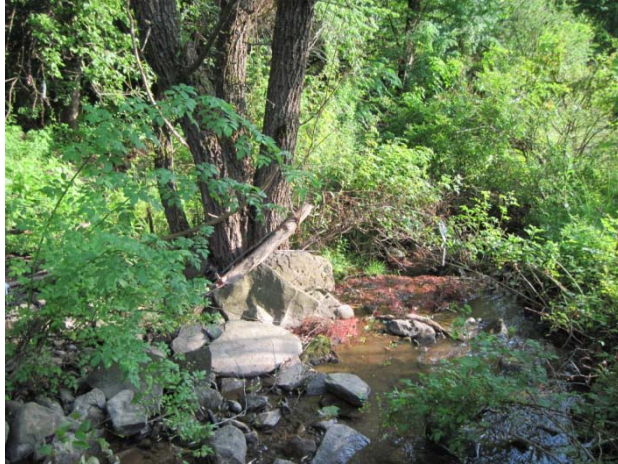
**DE-1P-S053**

Concerned about maintaining the step pool morphology of the stream. The pipeline must be protected by grade control structures.

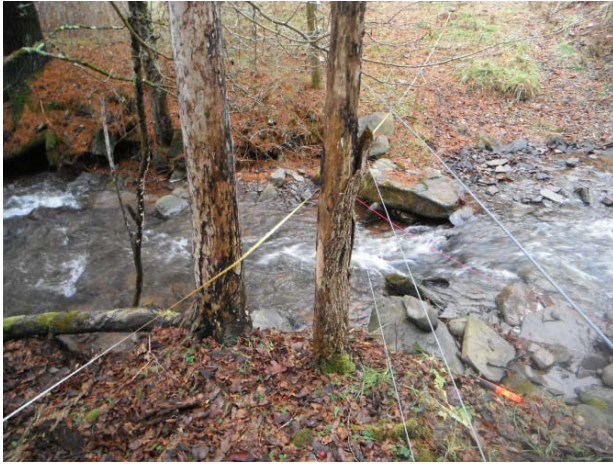
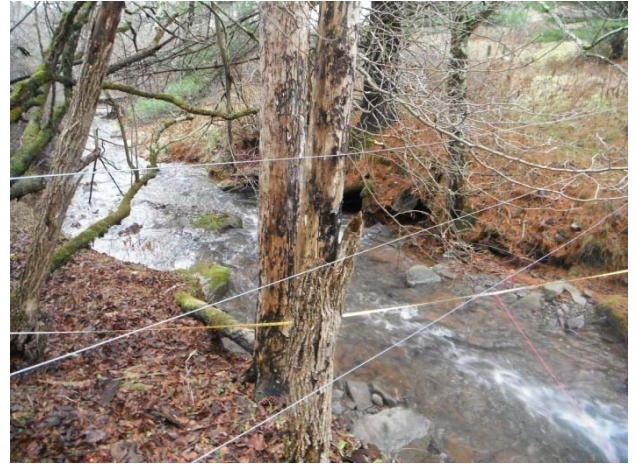
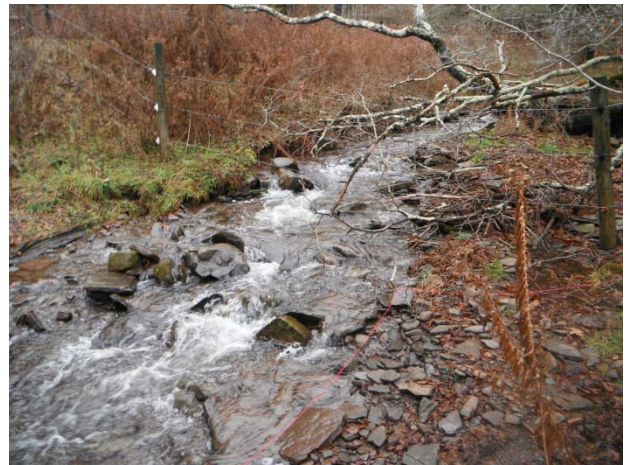
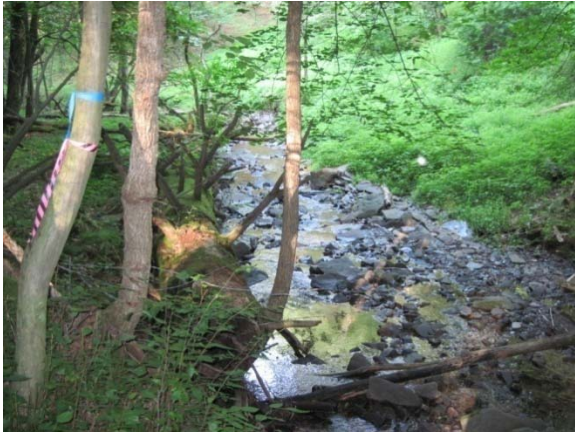
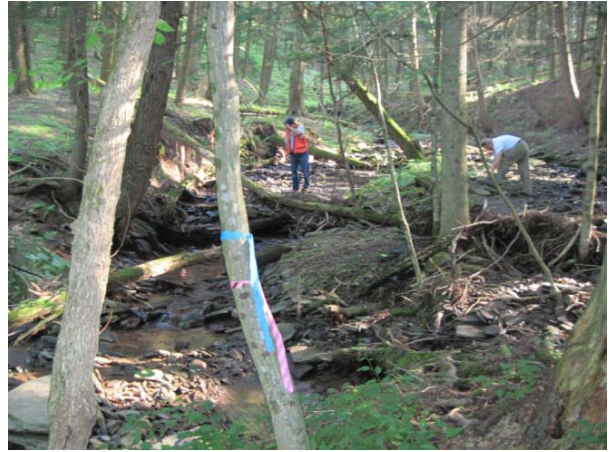
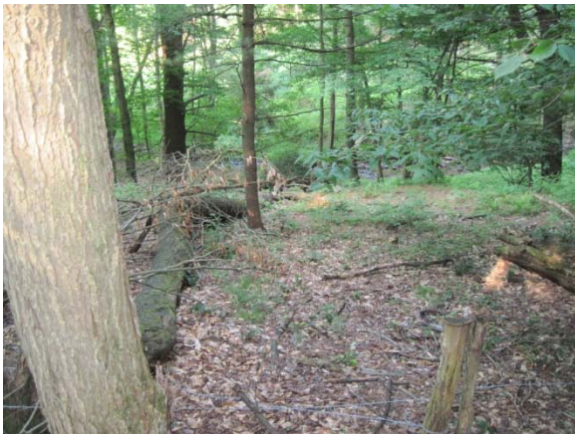
**DE-1P-S054**

This channel is predominantly a riffle reach of stream with a few pools scattered along it. The bed material is predominantly cobble, with some small boulders and gravel mixed in. The largest pool was located about 100' downstream of the crossing, and was caused by a log-jam upstream. Trout were observed in this pool during the site visit. This stream appears to be flowing year-round and would provide adequate trout habitat, as it is mostly shaded and has suitable substrate. This reach was generally stable; although the log jam downstream of the crossing could potentially move upstream and impact the pipeline crossing. There is an existing farm access road about 5' upstream of the crossing that is stable and has lower banks. Some erosion was evident along the areas of the reach where the side slopes were higher (~15% of the reach) and the water was confined to a narrower channel – however, this erosion did not appear to be recent, as no actively slumping banks were observed, other than in the area of the log jam. For the most part there was minimal meandering of the channel. There was an old logging/access road on the left bank of the channel, down to the location of the pipeline crossing. Above the crossing the area is primarily wooded. In the area downstream of the crossing, there is a ~25' wide riparian buffer on both sides of the stream, with pasture beyond that. The floodplain is almost non-existent (abandoned about 3' above the existing waterline and at the elevation of the pasture) downstream of the crossing. Upstream of the crossing, the floodplain may be accessed by the channel a few times a year, as it is about 18" above the existing water line.

The regulators want the crossing moved downstream onto a property with no access. There is an existing agricultural ford there that would make a better crossing.

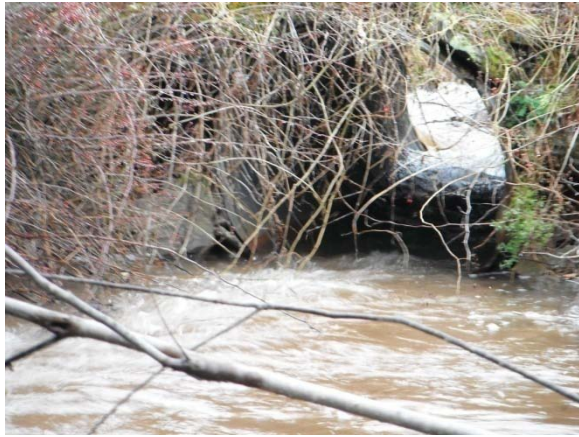
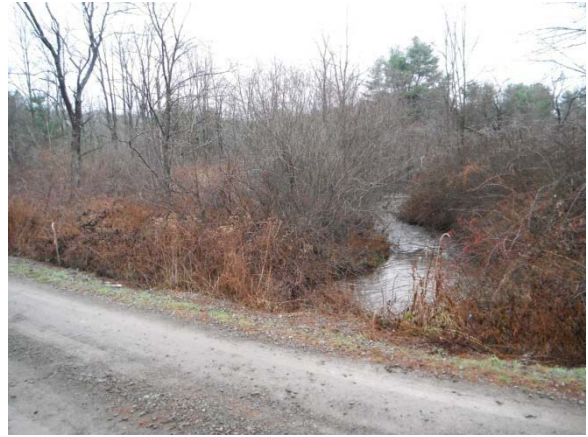
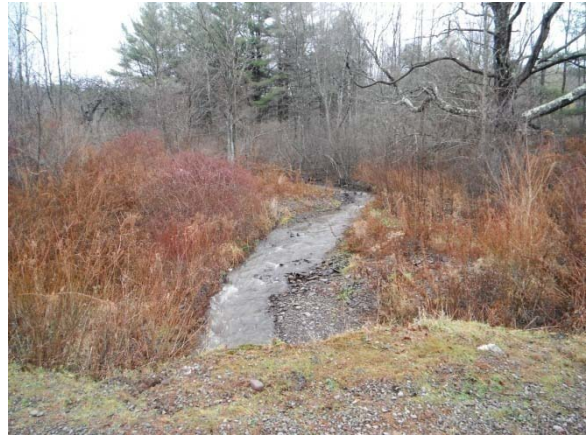
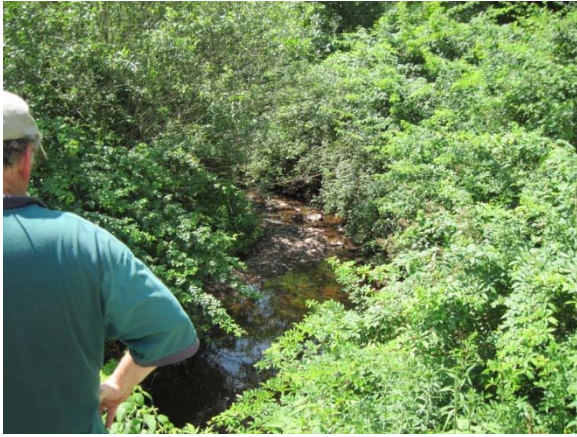
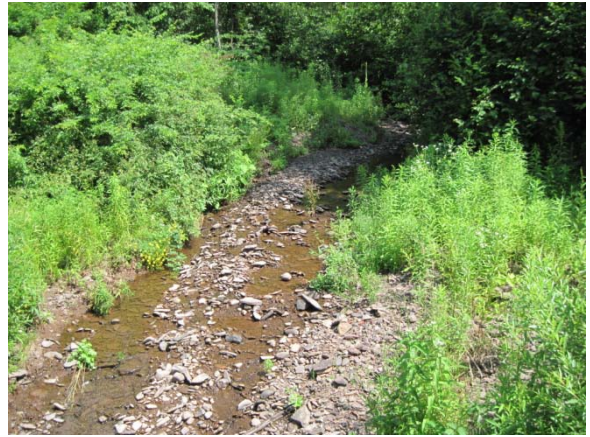
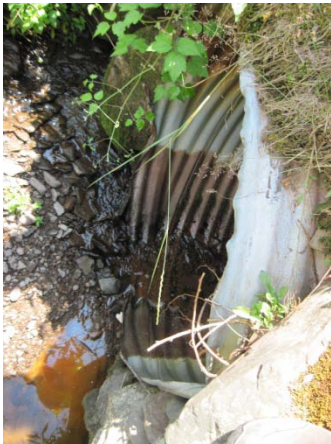
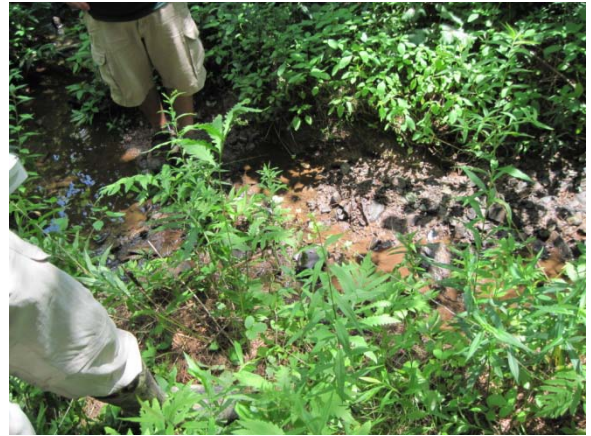
**DE-1P-S056**

At this site there is a driveway with a culvert underneath it directly upstream of the crossing. The channel consists of a silty, gravelly, cobble substrate with a well-connected floodplain on the left bank. The right bank is partially connected to the channel and generally rises up about 3' at approximately a 5:1 slope above the bankfull elevation. The site did not appear to be great trout habitat, as it was a meandering channel though a silty substrate, but there is valuable aquatic insect habitat that may serve as a food source for trout downstream. There was minimal active erosion observed during the site visit in December, but the meandering channel did have some evidence of active erosion on the bends below the crossing. A ~2.5' deep pool lies below the culvert, right in the path of the crossing.

Existing culvert is perched with plunge pool. 36" culvert is likely large enough. Trout present in abundance. Groundwater supplies cold base flow. Crossing is at a private landowner driveway with adjacent wetlands and open fields. Although the present culvert appears to be satisfactory, it could be replaced with an open arch or box culvert sized at the required bankfull width. There was concern regarding shade removal as DE-1P-S056A is a great source of cold water, therefore the alder/shrubs should be replaced.

Crossing site is satisfactory. Concerned about thermal impacts particularly at the adjacent cold water seeps (58°F).

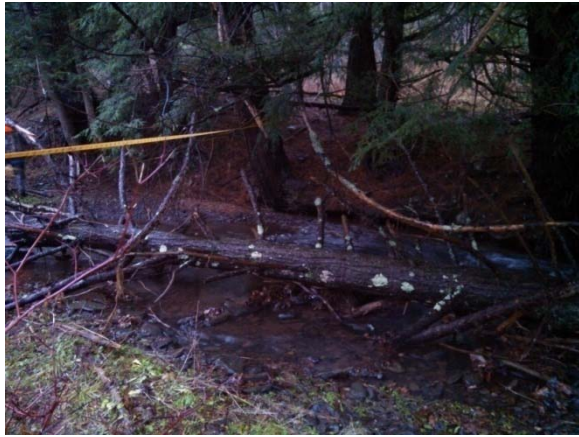
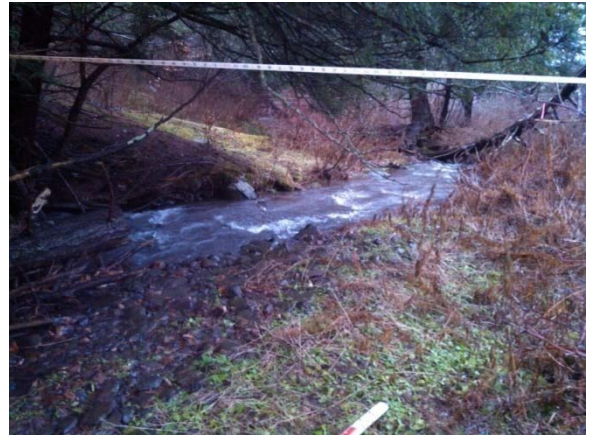
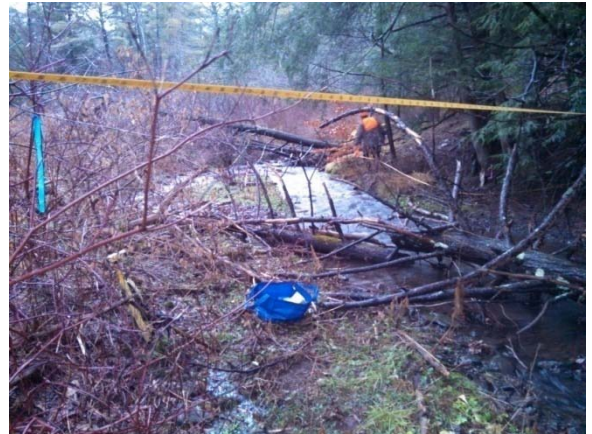
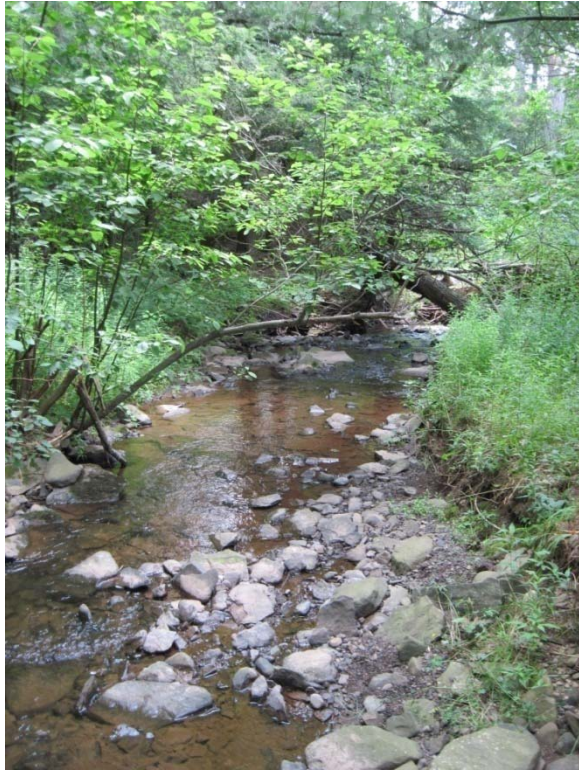
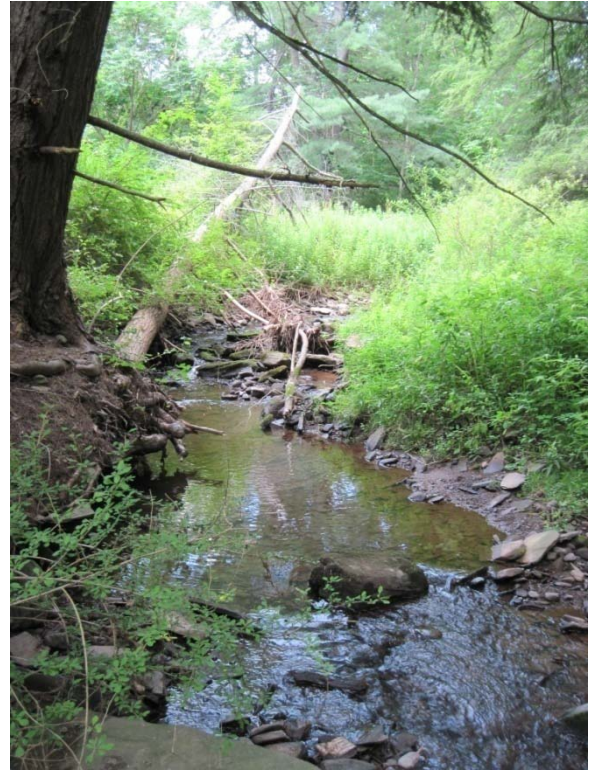
**DE-1P-S058**

There is an approximately 0.25 acre wetland over the top of the left bank at the crossing (Transect A). This area is connected to the stream and it collects runoff from the hillslope and directs it to the stream approximately 90' downstream of the crossing. The pool/riffle stream is generally stable downstream of transect A with good stream shading and mix of riffles and pools. The area from about 140' to 80' above transect A is laterally and vertically unstable due to the overtopping of an access road caused by a plugged culvert. There are two large trees that have fallen into or across the stream, which could provide a significant debris jam. The substrate is generally cobble and small boulders, with some soil exposed in the areas of the unstable area above transect B. The banks are generally stable and only have minor erosion along ~15% of the reach, aside from the erosion associated with the culvert upstream of the crossing.

The site was accessed via an existing roadway that had a culvert that was about 95% plugged by debris, which had recently caused the roadway to be overtopped and a channel to develop on the left bank downstream of the roadway and approximately 120' upstream of the proposed crossing. Both the historic and new channels contained flowing water. There is an active headcut (~18" tall) forming in the new channel caused by the stream overtopping the roadway. This headcut is upstream of the crossing and should not contribute to any instability at the crossing site.

Crossing site is satisfactory. Concerned about thermal impacts particularly at the adjacent cold water seeps (58°F).

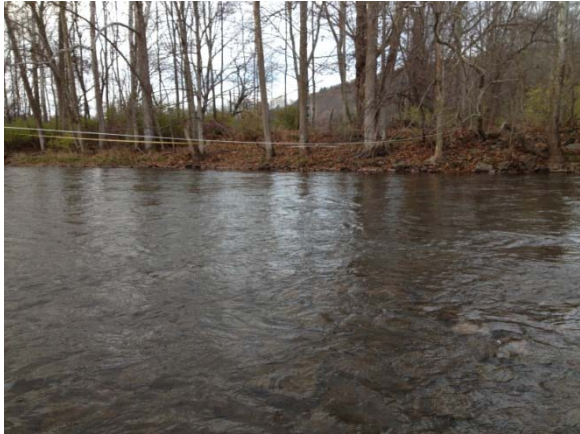
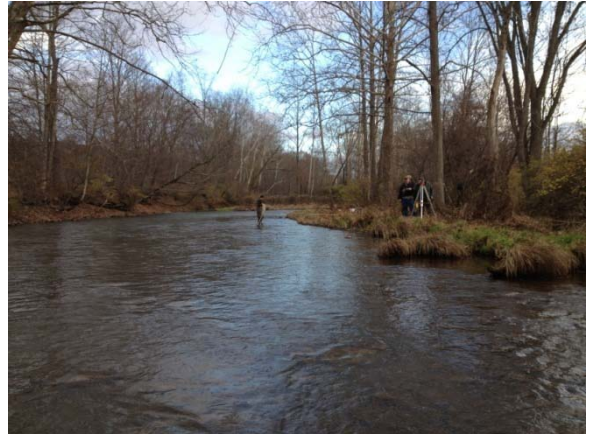
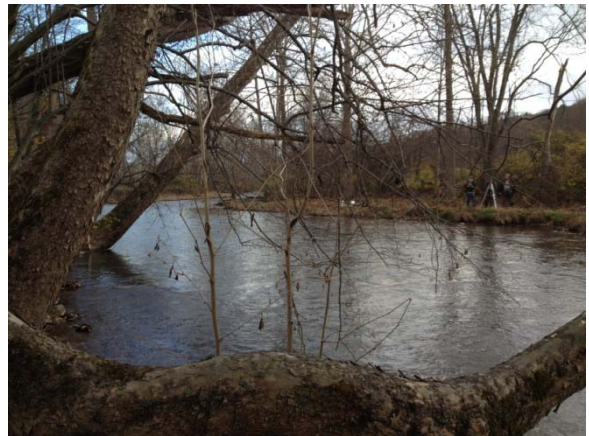
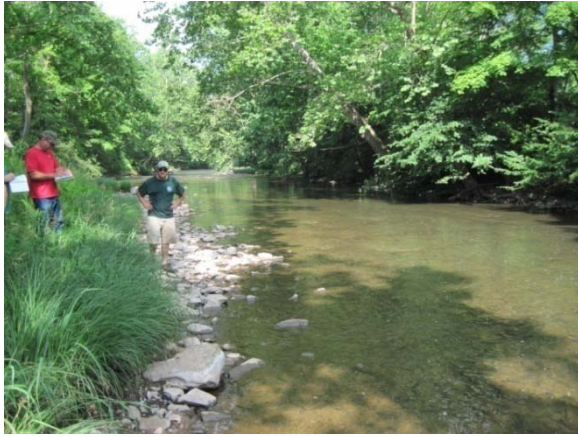
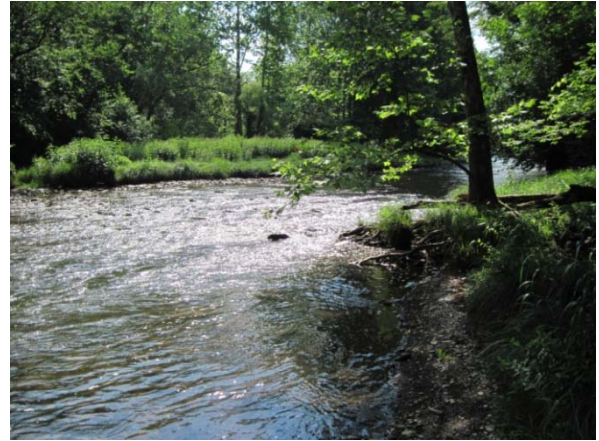
**DE-1P-S129**

Location is satisfactory. Bank stabilization on outer bend at crossing is important and planting will be necessary to stabilize the bank after installation. Need to have a planting plan and stabilization plan in place. Concerned that loss of riparian trees will destabilize the bank. Grade control structures (rock riffle) suggested to minimize risk of exposing the pipeline.

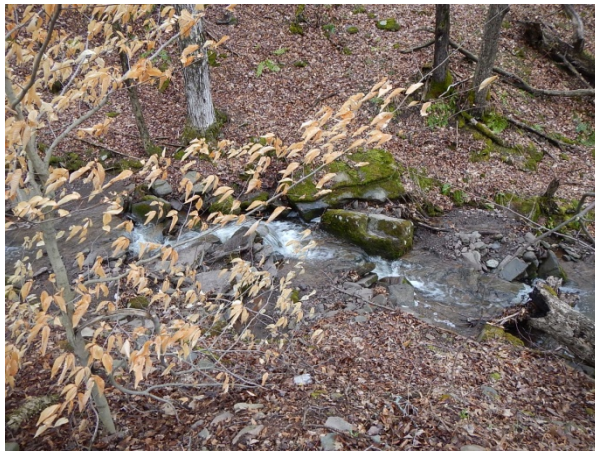
**DE-XX-S79.36**

This stream is confined with steep valley walls on either side and small, discontinuous floodplain benches in some places. It is steep in grade (approx 4-6%) and has a mix of boulder and cobble bed material in the bed. Given its steep grade and the sparseness of the boulder material, additional grade control measures are recommended. The DEC suggested that hardened step pools be used to convey the flow through this reach and that live stakes be used to quickly re-establish vegetation on the steep banks on either side of the stream. Hardened step pools could use large boulders covered with existing bed material.

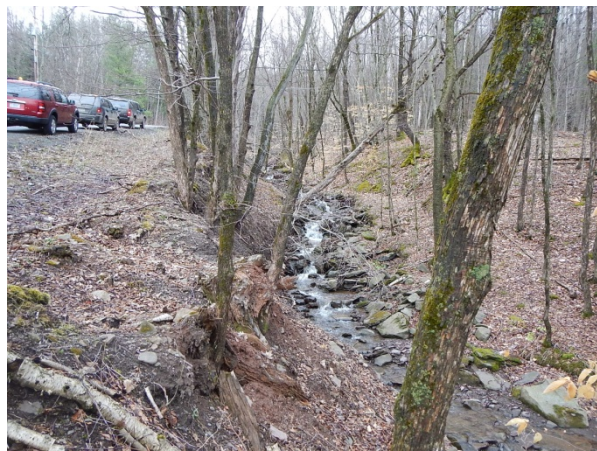
**CROSSING: LOOKING UPSTREAM**

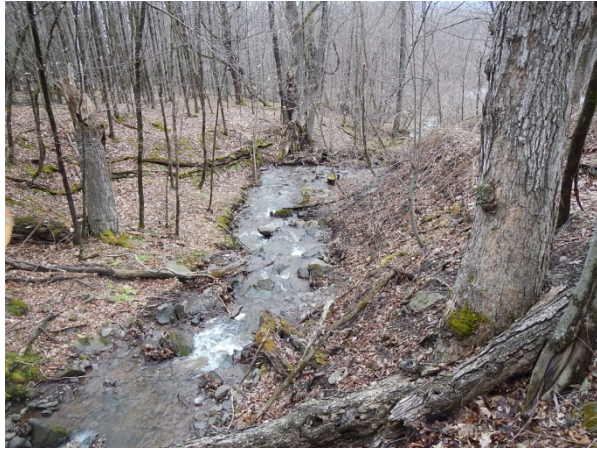
**CROSSING: LOOKING DOWNSTREAM**

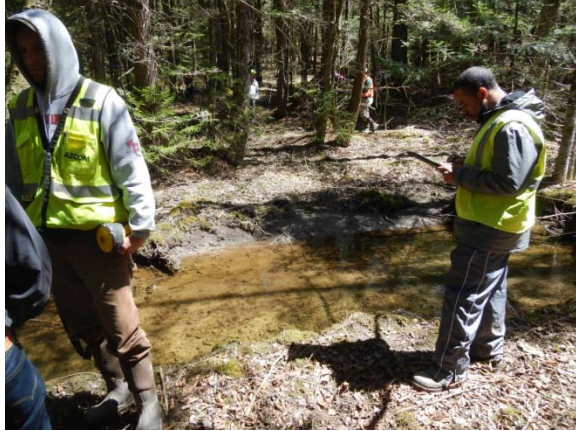
CROSSING

This is a braided stream system, likely caused by significant debris jams that have formed and subsequently silted in behind them. There was a primary channel carrying approximately 60% of the flow, but several other side channels were flowing as well. The stream was well connected with its wide floodplain and evidence of overbank flow was obvious. There were some small (1' tall) overhanging banks with exposed roots, which may be evidence that this channel is still sorting out its preferred path.

The NYSDEC was concerned with reconnecting all the side channels and making sure that flow was restored to all parts of this complex braided stream system. They requested that large woody debris be returned to the stream reach after installing the pipeline. Trout were observed at this site and timing restrictions would apply.

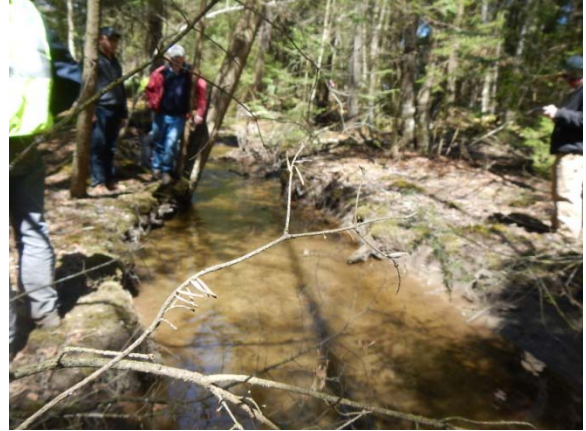
CROSSING: LOOKING UPSTREAM

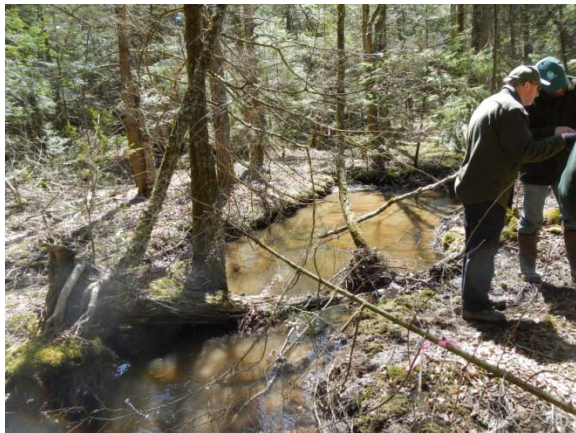
CROSSING: LOOKING DOWNSTREAM

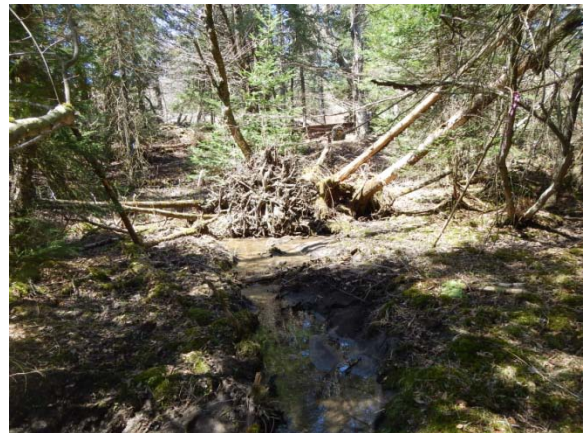
CROSSING: LOOKING UPSTREAM ON SIDE CHANNEL

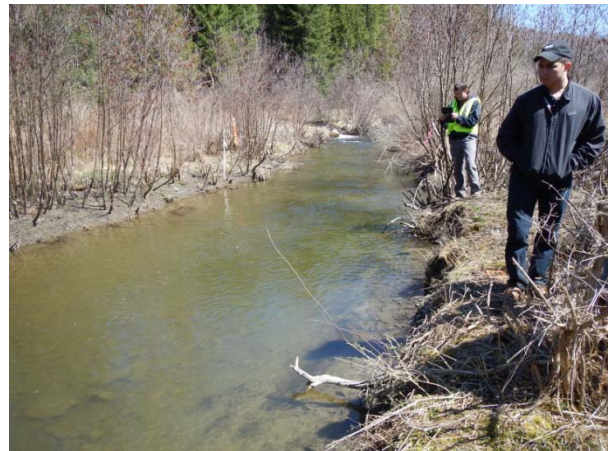
CROSSING LOOKING UPSTREAM

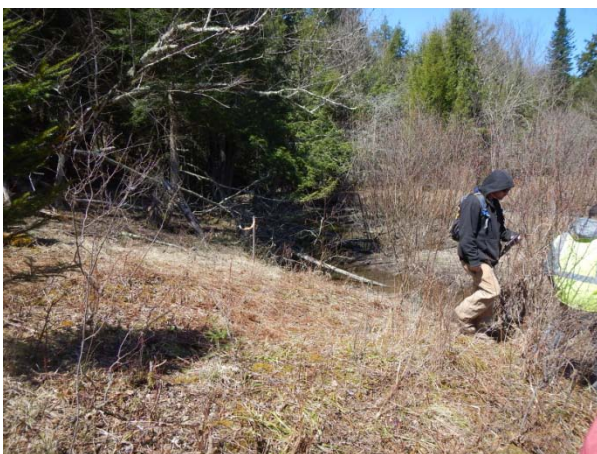
CROSSING LOOKING DOWNSTREAM

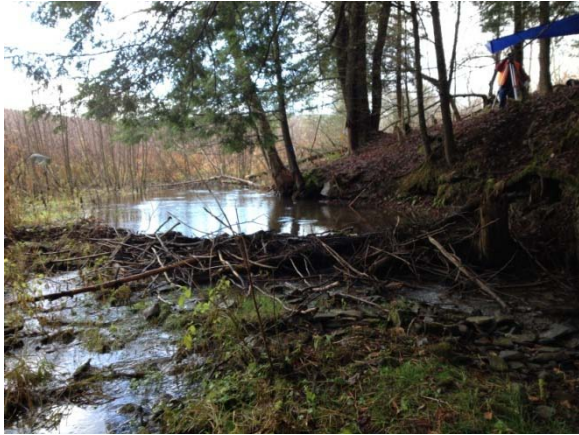
PREVIOUS CROSSING: BEAVER DAM  
IMPOUNDMENT

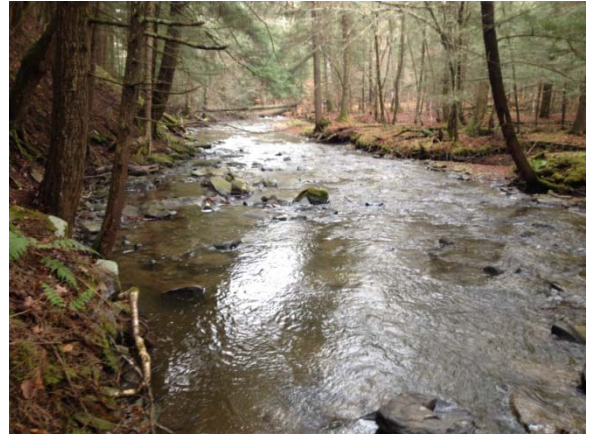
PREVIOUS CROSSING: LOOKING DOWNSTREAM

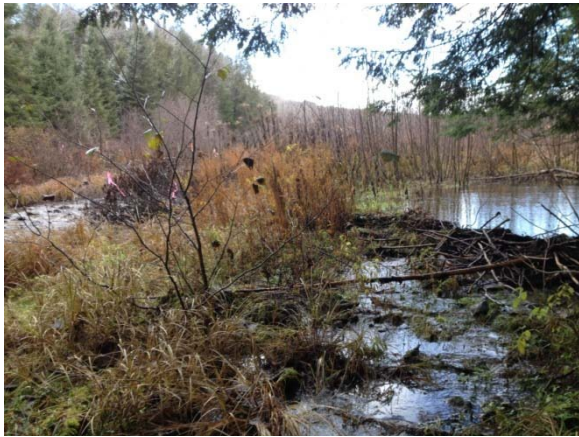
PREVIOUS CROSSING: SIDE CHANNEL AND  
STREAM ELEVATION DIFFERENCE

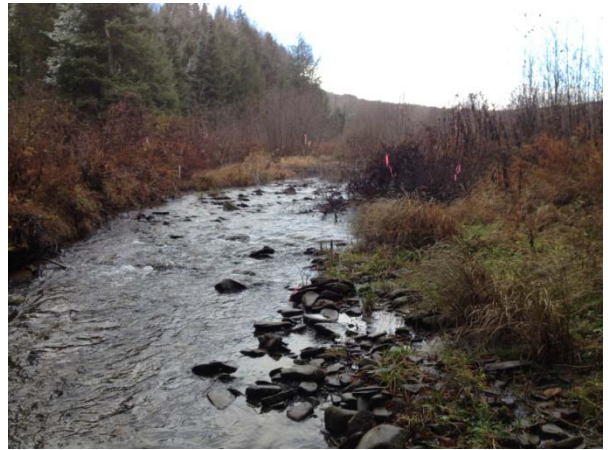
PREVIOUS CROSSING: LOOKING UPSTREAM

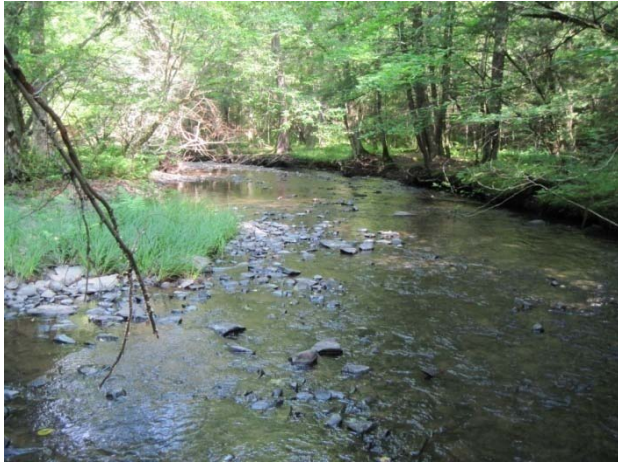
PREVIOUS CROSSING: LOOKING DOWNSTREAM

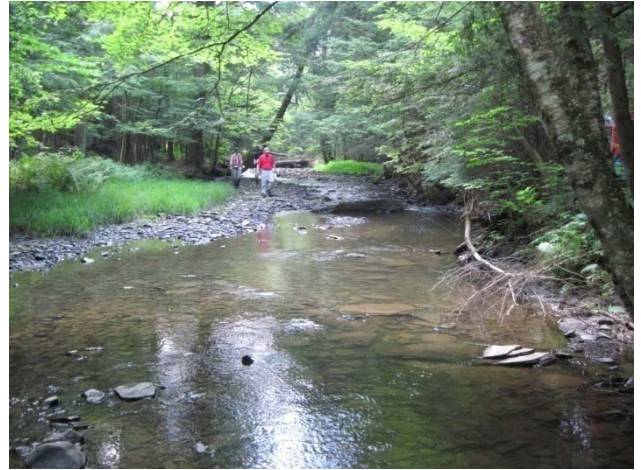
PREVIOUS CROSSING: LOOKING UPSTREAM

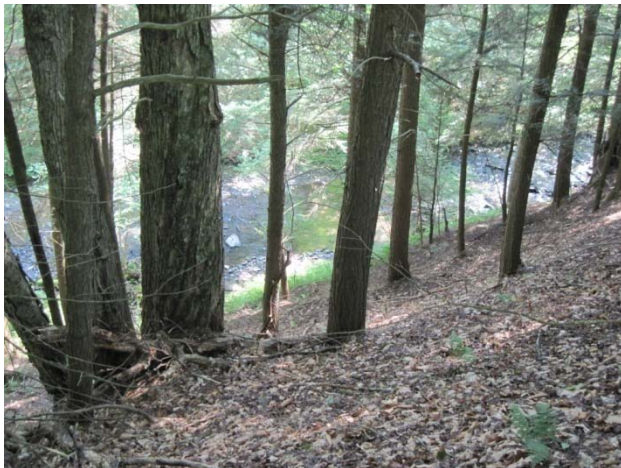
PREVIOUS CROSSING: TOP OF BANK

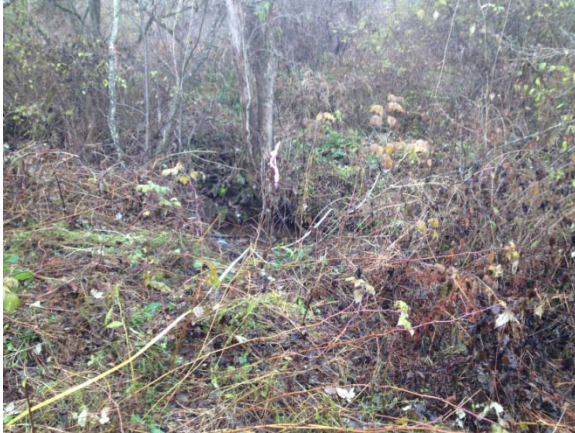
PREVIOUS CROSSING

Too much gradient at proposed site. Moving the crossing downstream will decrease the risk of exposing the pipeline and require less tree removal. The wetland impacts would likely remain the same.

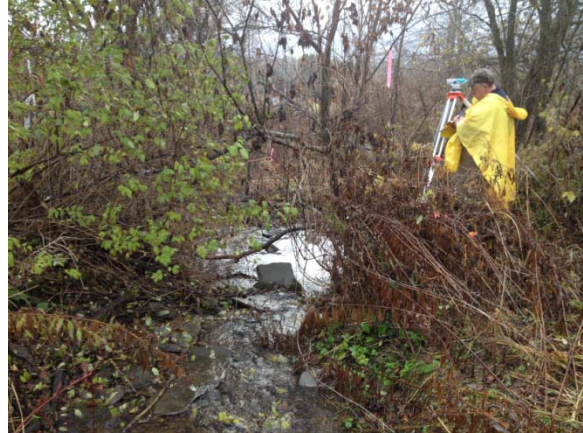
PREVIOUS CROSSING: LOOKING DOWNSTREAM

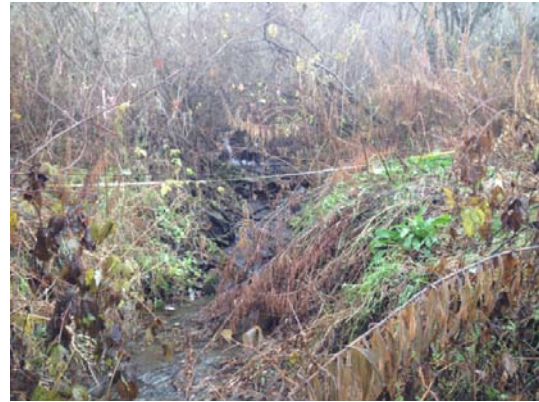
UPSTREAM OF PREVIOUS CROSSING:  
LOOKING UPSTREAM

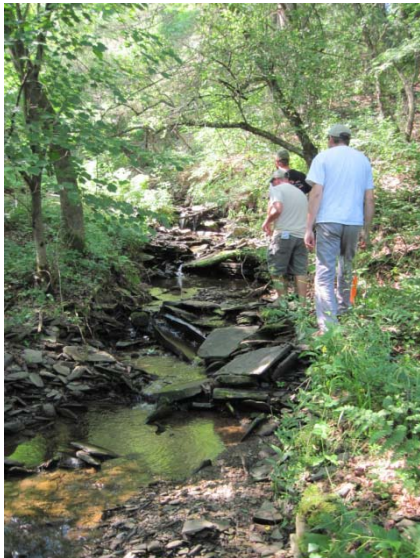
PREVIOUS CROSSING: DOWNSTREAM

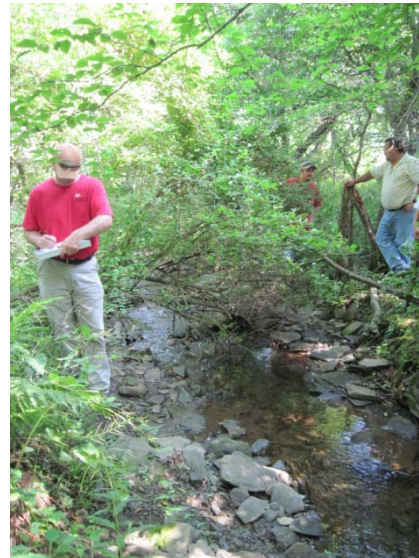
PREVIOUS CROSSING: UPSTREAM

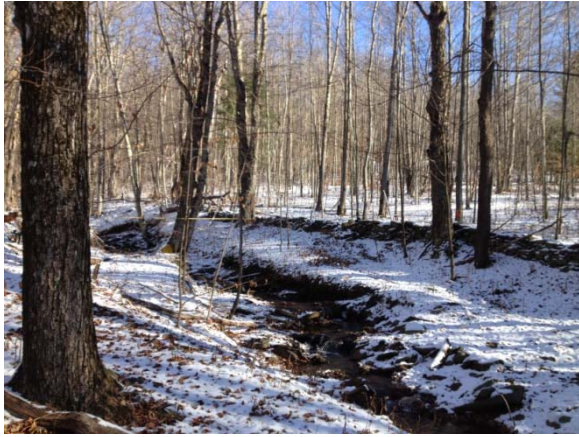
CROSSING

Located in a deciduous forest with good cover, the stream is an incised, high gradient stream that may have been recently degraded by hurricanes. Reroute to further downstream was discussed.

NYSDEC was concerned about possible head cut from downstream. They recommended grade control features downstream of pipeline crossing to prevent future exposure. It was also mentioned that the downed trees in stream should be left in place as they provide grade control.

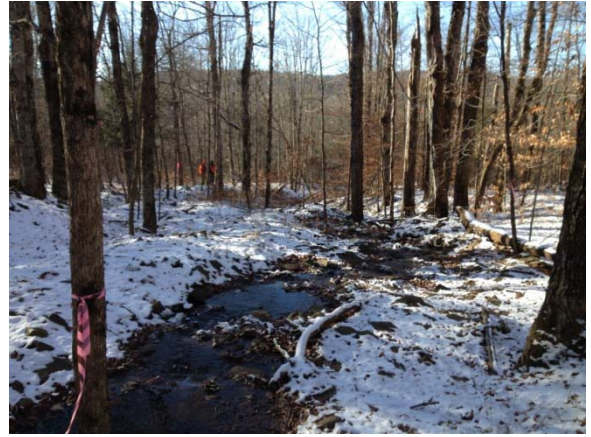
CROSSING: LOOKING DOWNSTREAM

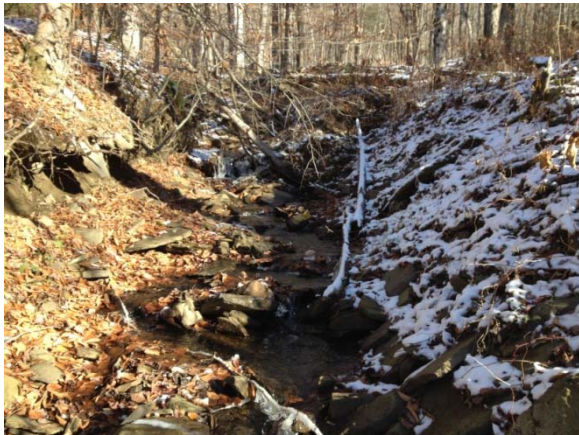
STEEPLY ERODED BANKS UPSTREAM OF  
CROSSING

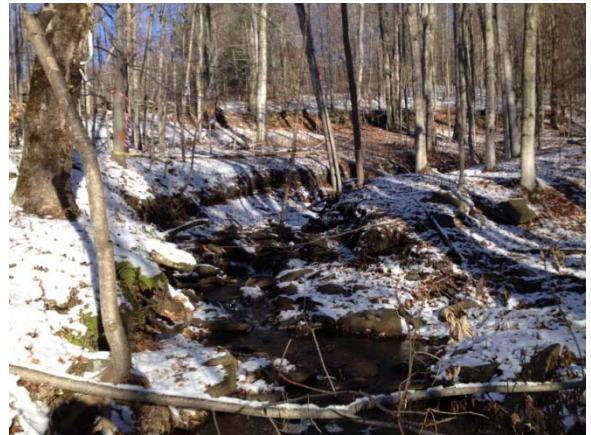
CROSSING: LOOKING UPSTREAM

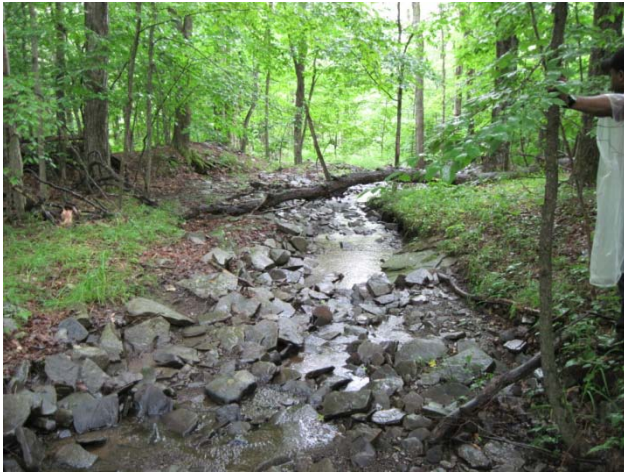
PREVIOUS CROSSING: DOWNSTREAM
