CONSTITUTION PIPELINE

**ATTACHMENT Q**  
**TROUT STREAM RESTORATION REPORT**  
**New August 2014**

## **CONSTITUTION PIPELINE NEW YORK TROUT STREAM CROSSINGS**

August 2014

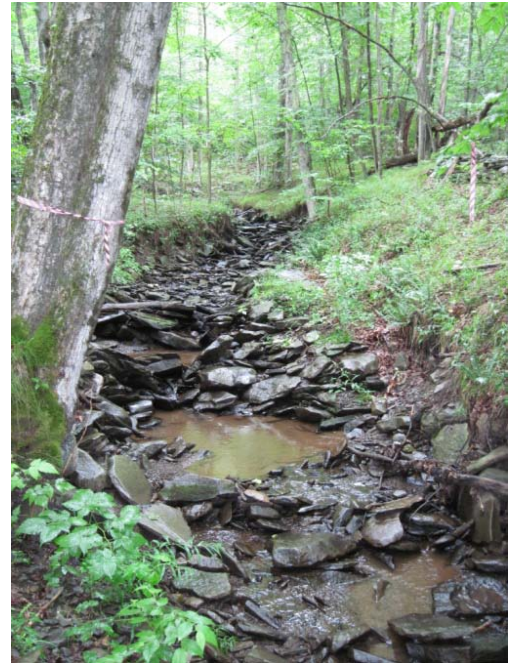
PREVIOUS CROSSING: UPSTREAM
